## Thermographic Survey

### Sample Company

Attn: Re: Annual Infrared Scan

## THERMOGRAPHIC INSPECTION REPORT

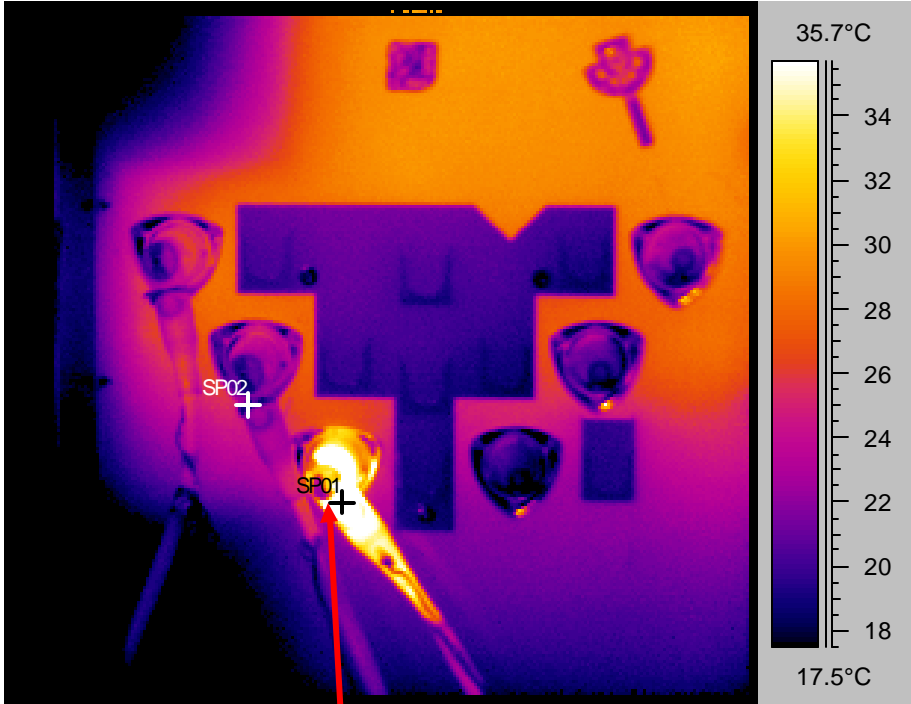
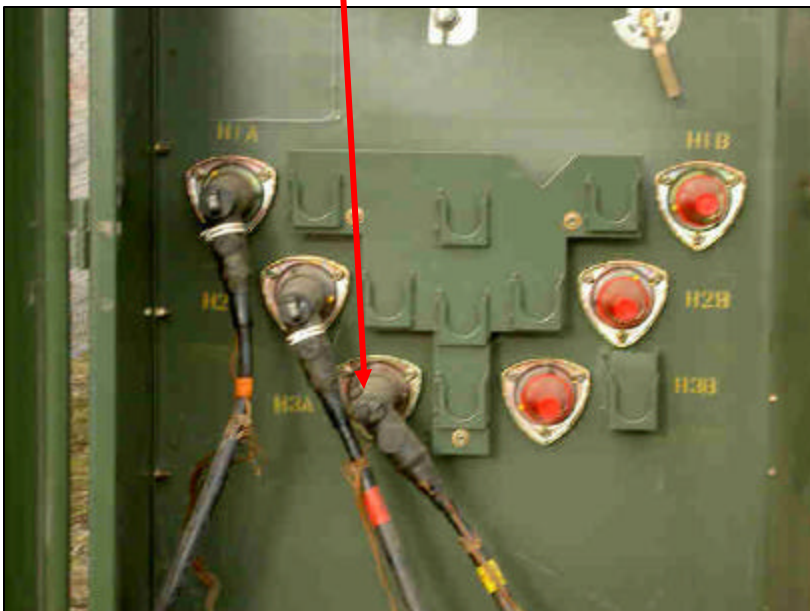
2500kVA Transformer

<b>Problem #</b>	<b>1</b>
<b>Repair Priority</b>	<b>Critical</b>
<b>Hot Spot</b>	<b>43.0°C</b>
<b>Ref. Temp</b>	<b>19.0°C</b>
<b>Delta T</b>	<b>24.0</b>
<b>Time</b>	<b>Any Time</b>
<b>Date</b>	<b>Any Day</b>

The connection is overheating by **24°C**. High Voltage elbow terminator may have a defective "cable-to-terminator" connection inside the elbow terminator.

Replace the deficient High Voltage elbow terminator. Based on our experience, the best solution is to replace the elbow terminator.

**Critical Repair Priority** - Repair as soon as possible.

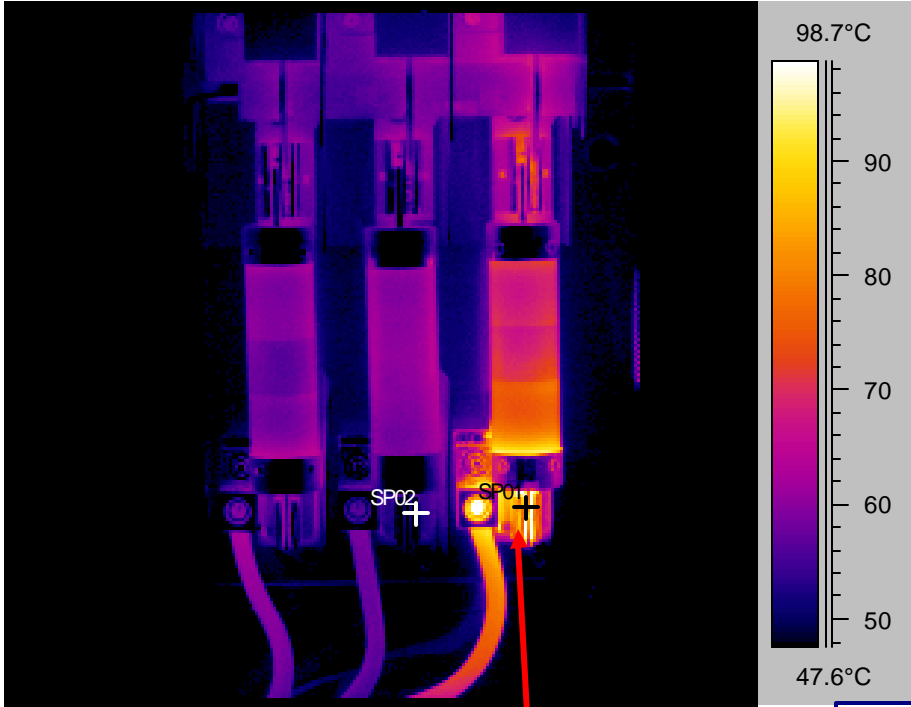
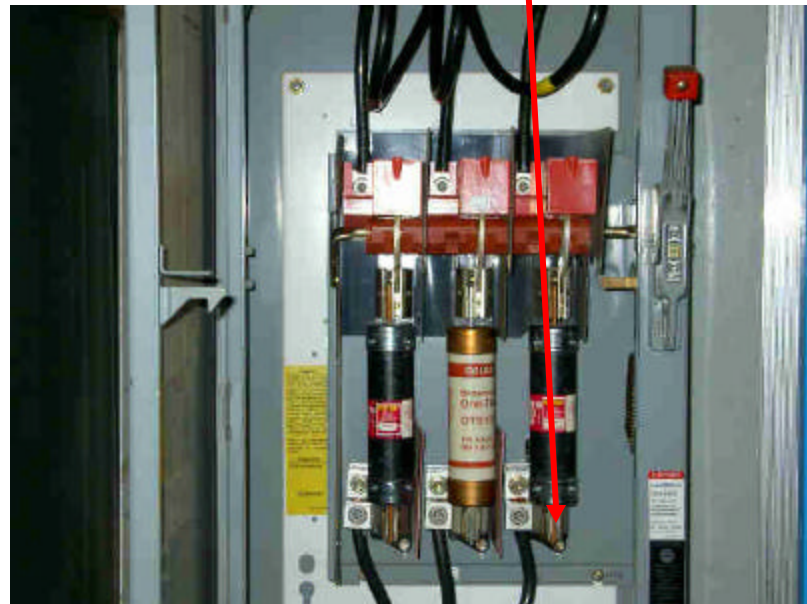
Switch #2

<b>Problem #</b>	<b>2</b>
<b>Repair Priority</b>	<b>Critical</b>
<b>Hot Spot</b>	<b>104.3°C</b>
<b>Ref. Temp</b>	<b>47.4°C</b>
<b>Delta T</b>	<b>57.0</b>
<b>Time</b>	<b>Any Time</b>
<b>Date</b>	<b>Any Day</b>

The lower C phase fuse clip and wire connection are hot. A dirty or loose connection is suspected.

Clean the fuse contact surfaces and fuse clip, reassemble. Check fuse clip for proper tension. Disconnect the wire. Clean the wire and lug. Inspect for signs of burning or pitting. Reassemble. Make sure the lug is properly torqued.

**Critical Repair Priority** - Repair as soon as possible.

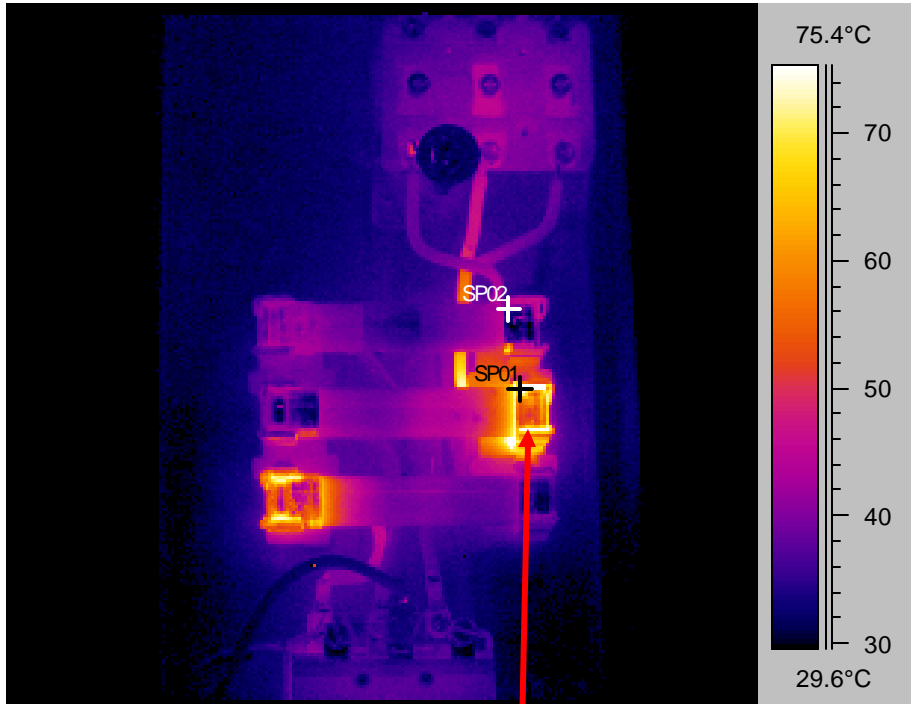
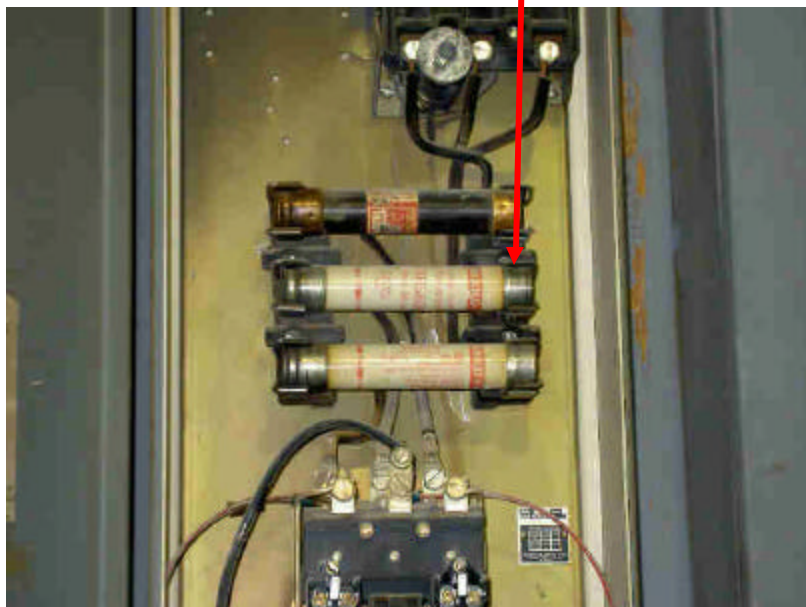
Switch #1

<b>Problem #</b>	<b>3</b>
<b>Repair Priority</b>	<b>Urgent</b>
<b>Hot Spot</b>	<b>79.4°C</b>
<b>Ref. Temp</b>	<b>36.0°C</b>
<b>Delta T</b>	<b>43.4</b>
<b>Time</b>	<b>Any Time</b>
<b>Date</b>	<b>Any Day</b>

The lower left and center right fuse clips are hot. Loose wire connections or poor fuse clip tension is suspected.

Remove all the fuses, clean the fuse contact areas and fuse clip contact areas, reassemble. Check fuse clips for proper tension. Replace if necessary. Clean the wire to lug connection. Check all the lugs for proper torque.

**Urgent Repair Priority** - Repair at earliest opportunity.
