Outdoor Substation

2500kVA Transformer

Problem #	1
Repair Priority	Critical
Hot Spot	43.0°C
Ref. Temp	19.0°C
Delta T	24.0
Time	Any Time
Date	Any Day

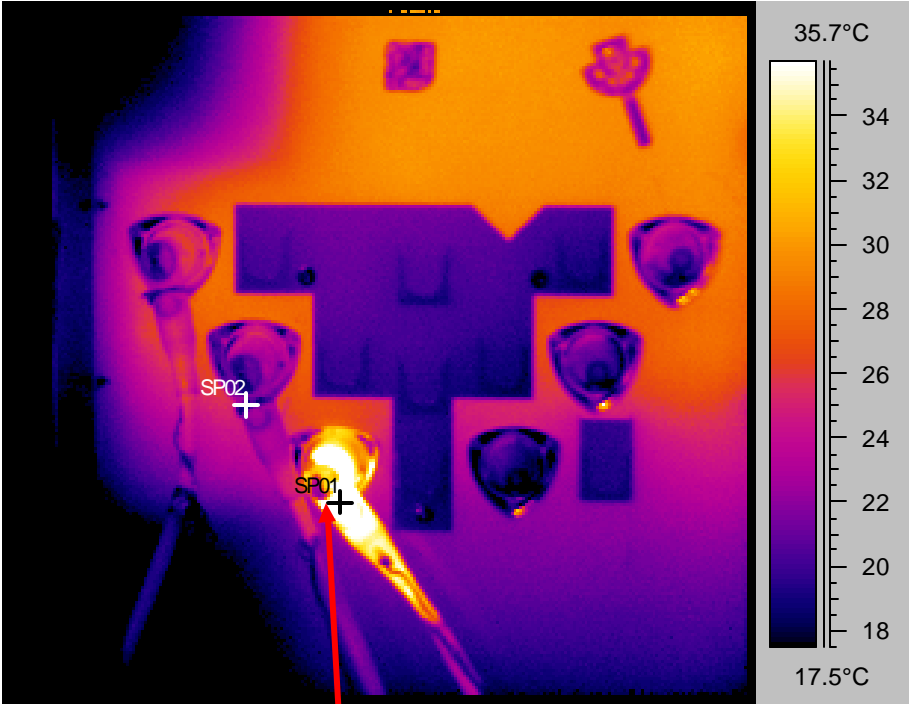
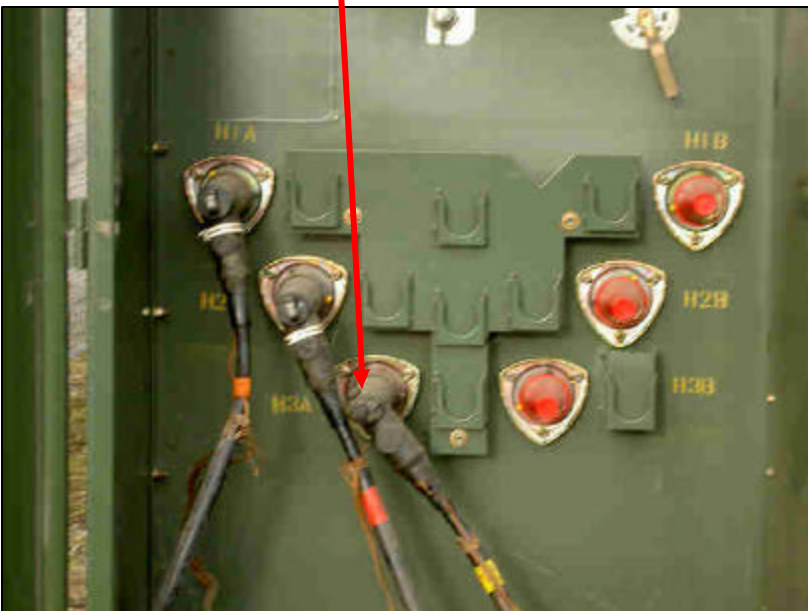
The connection is overheating by **24°C**. High Voltage elbow terminator may have a defective "cable-to-terminator" connection inside the elbow terminator.

Critical Repair Priority - Repair as soon as possible.

Replace the deficient High Voltage elbow terminator. Based on our experience, the best solution is to replace the elbow terminator.
