Electrical Testing and Maintenance Co., Inc.  
5141 North 35th St., Milwaukee, WI 53209  
414.931.0992 / 414.461.8485 Fax

1060 Breezewood Lane, Suite #4  
Neenah, WI 54956  
920.727.1600 / 920.727.1620 Fax

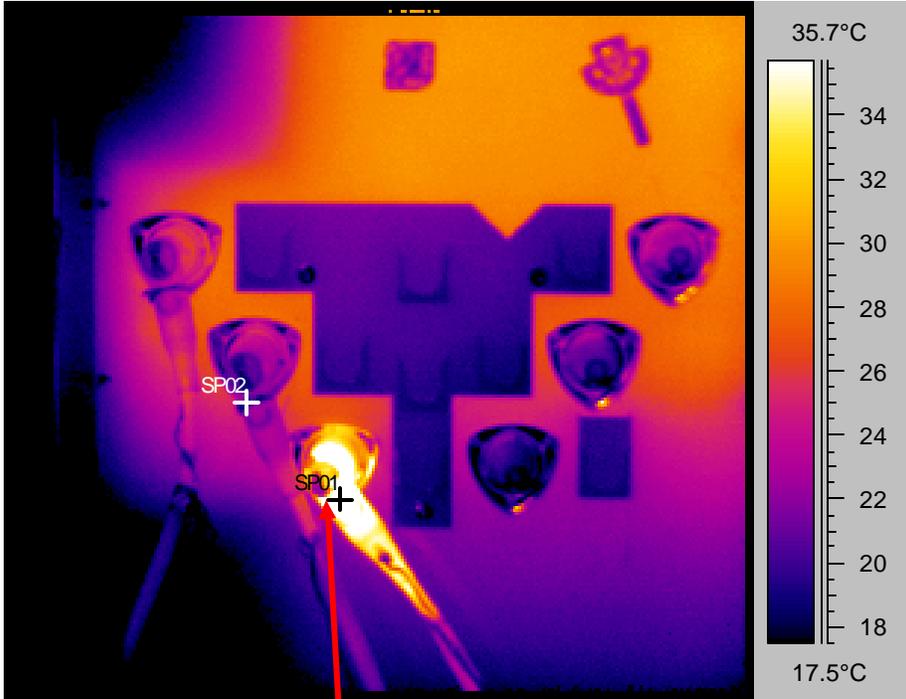
<b>Problem #</b>	<b>1</b>
<b>Repair Priority</b>	<b>Critical</b>
<b>Hot Spot</b>	<b>43.0°C</b>
<b>Ref. Temp</b>	<b>19.0°C</b>
<b>Delta T</b>	<b>24.0</b>
<b>Time</b>	<b>Any Time</b>
<b>Date</b>	<b>Any Day</b>

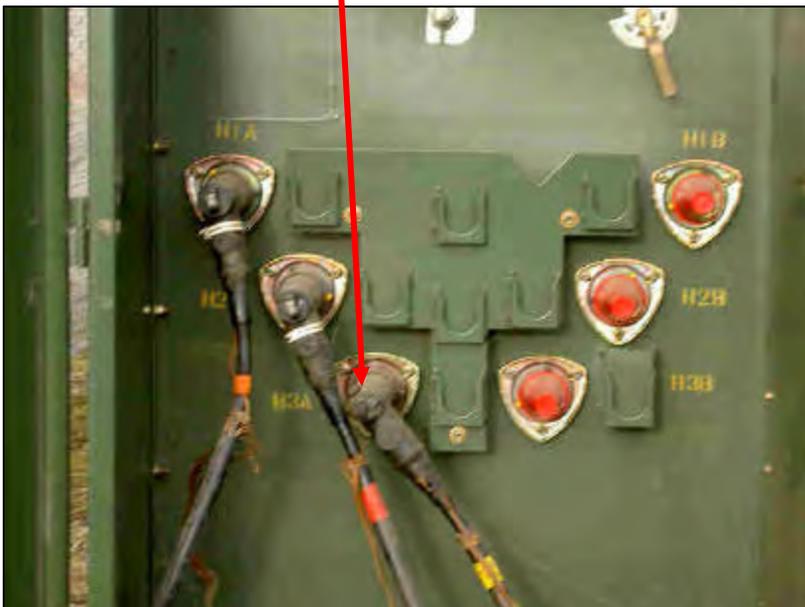
The connection is overheating by **24°C**. High Voltage elbow terminator may have a defective "cable-to-terminator" connection inside the elbow terminator.

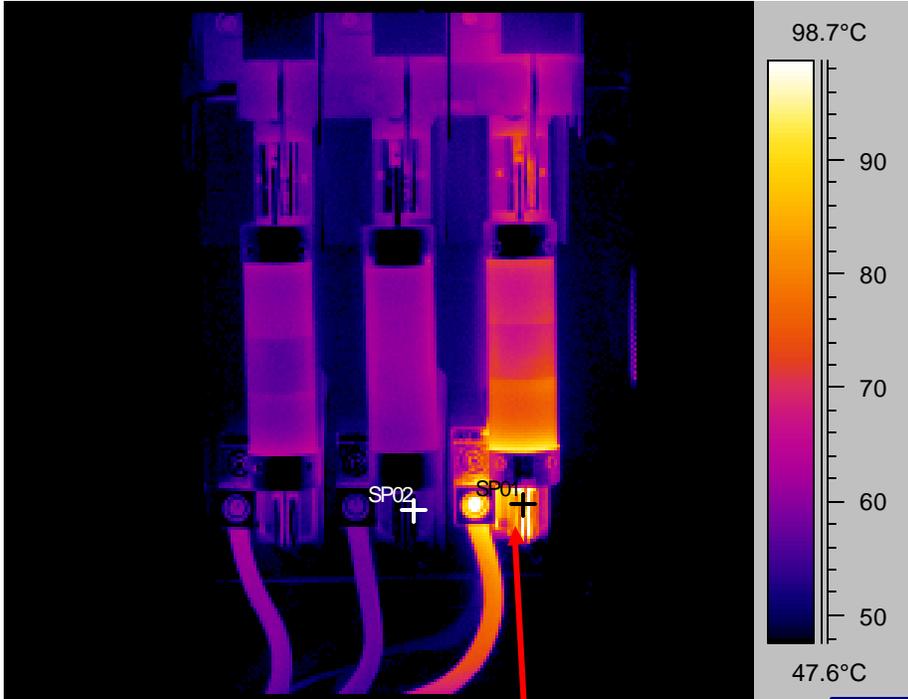
<b>Problem #</b>	<b>2</b>
<b>Repair Priority</b>	<b>Critical</b>
<b>Hot Spot</b>	<b>104.3°C</b>
<b>Ref. Temp</b>	<b>47.4°C</b>
<b>Delta T</b>	<b>57.0</b>
<b>Time</b>	<b>Any Time</b>
<b>Date</b>	<b>Any Day</b>

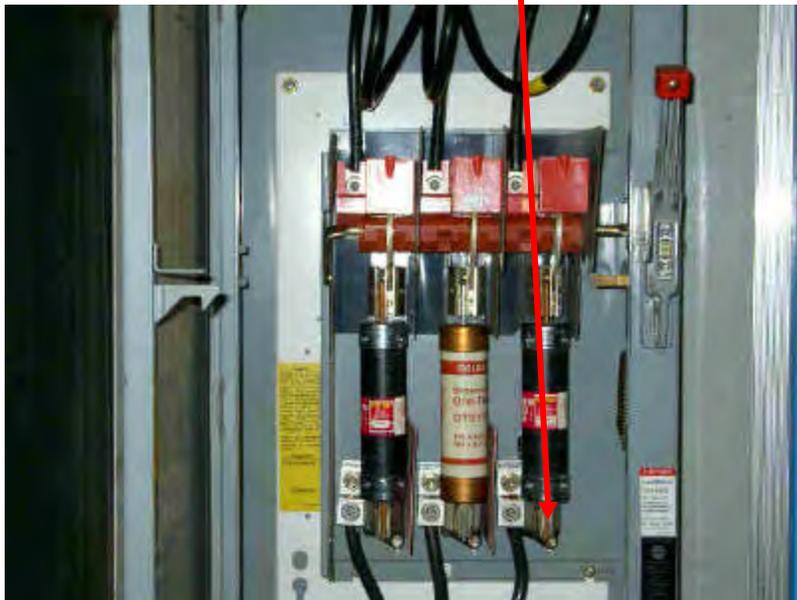
## MIDWEST ELECTRICAL TESTING

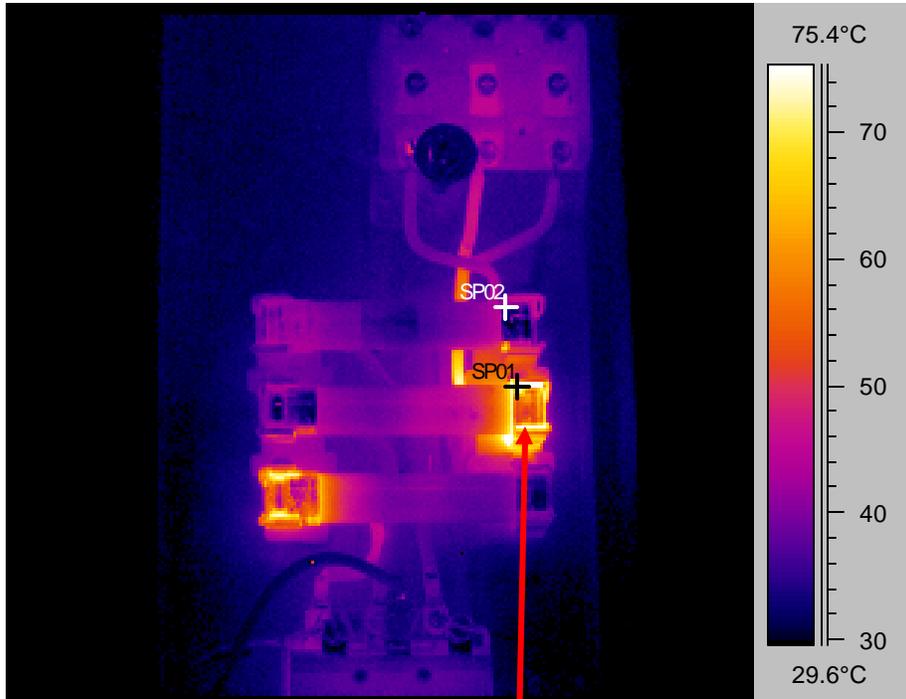
<b>Problem #</b>	<b>3</b>
<b>Repair Priority</b>	<b>Urgent</b>
<b>Hot Spot</b>	<b>79.4°C</b>
<b>Ref. Temp</b>	<b>36.0°C</b>
<b>Delta T</b>	<b>43.4</b>
<b>Time</b>	<b>Any Time</b>
<b>Date</b>	<b>Any Day</b>

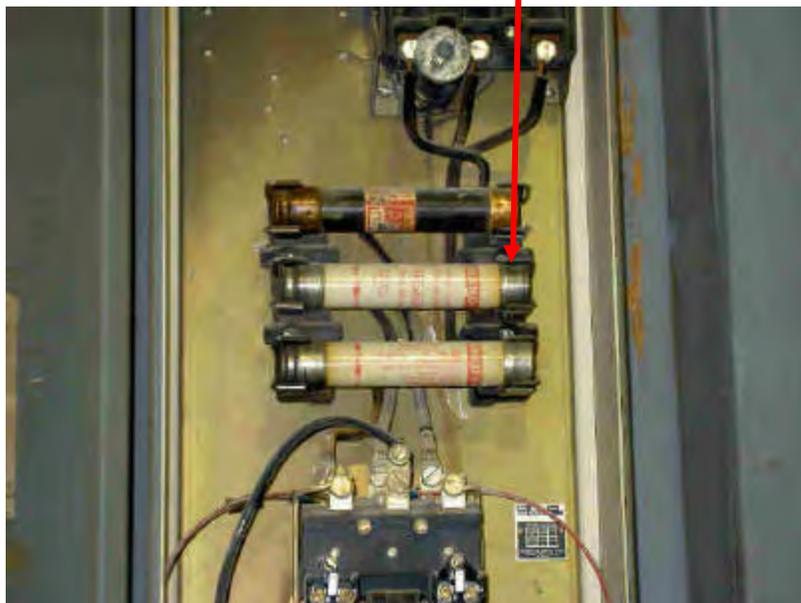
The lower left and center right fuse clips are hot. Loose wire connections or poor fuse clip tension is suspected.
