Sample Company

Main Electrical Room

Switch #1

Problem #	3
Repair Priority	Urgent
Hot Spot	79.4°C
Ref. Temp	36.0°C
Delta T	43.4
Time	Any Time
Date	Any Day

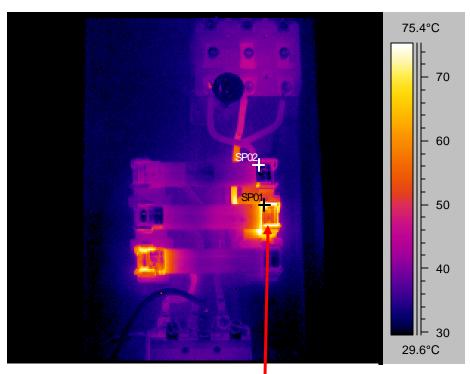
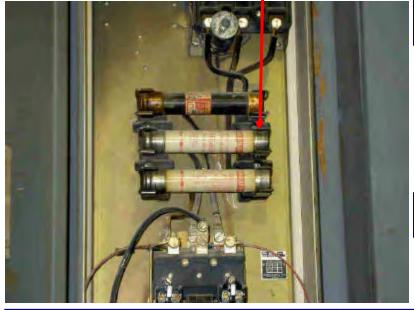
The lower left and center right fuse clips are hot. Loose wire connections or poor fuse clip tension is suspected.

Remove all the fuses, clean the fuse contact areas and fuse clip contact areas, reassemble. Check fuse clips for proper tension. Replace if necessary. Clean the wire to lug connection. Check all the lugs for proper torque.

Urgent Repair Priority - Repair at earliest opportunity.
