# Sample Company

Main Electrical Room

Switch #1

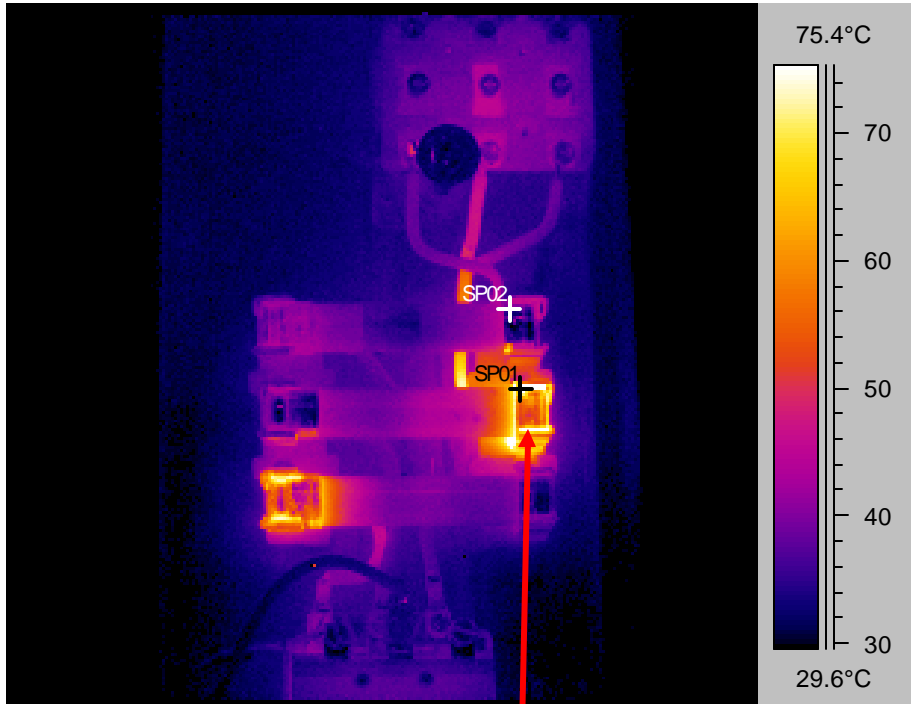
<b>Problem #</b>	<b>3</b>
<b>Repair Priority</b>	<b>Urgent</b>
<b>Hot Spot</b>	<b>79.4°C</b>
<b>Ref. Temp</b>	<b>36.0°C</b>
<b>Delta T</b>	<b>43.4</b>
<b>Time</b>	<b>Any Time</b>
<b>Date</b>	<b>Any Day</b>

The lower left and center right fuse clips are hot. Loose wire connections or poor fuse clip tension is suspected.

Remove all the fuses, clean the fuse contact areas and fuse clip contact areas, reassemble. Check fuse clips for proper tension. Replace if necessary. Clean the wire to lug connection. Check all the lugs for proper torque.

**Urgent Repair Priority** - Repair at earliest opportunity.
